Prime Eglinton Pty Ltd
Annual Compliance Report (EPBC 2017/7872)
19 (Lot 6) Taronga Place, Eglinton

6 January 2021
59303/133093 (Rev 0)
JBS&G Australia Pty Ltd T/A Strategen-JBS&G

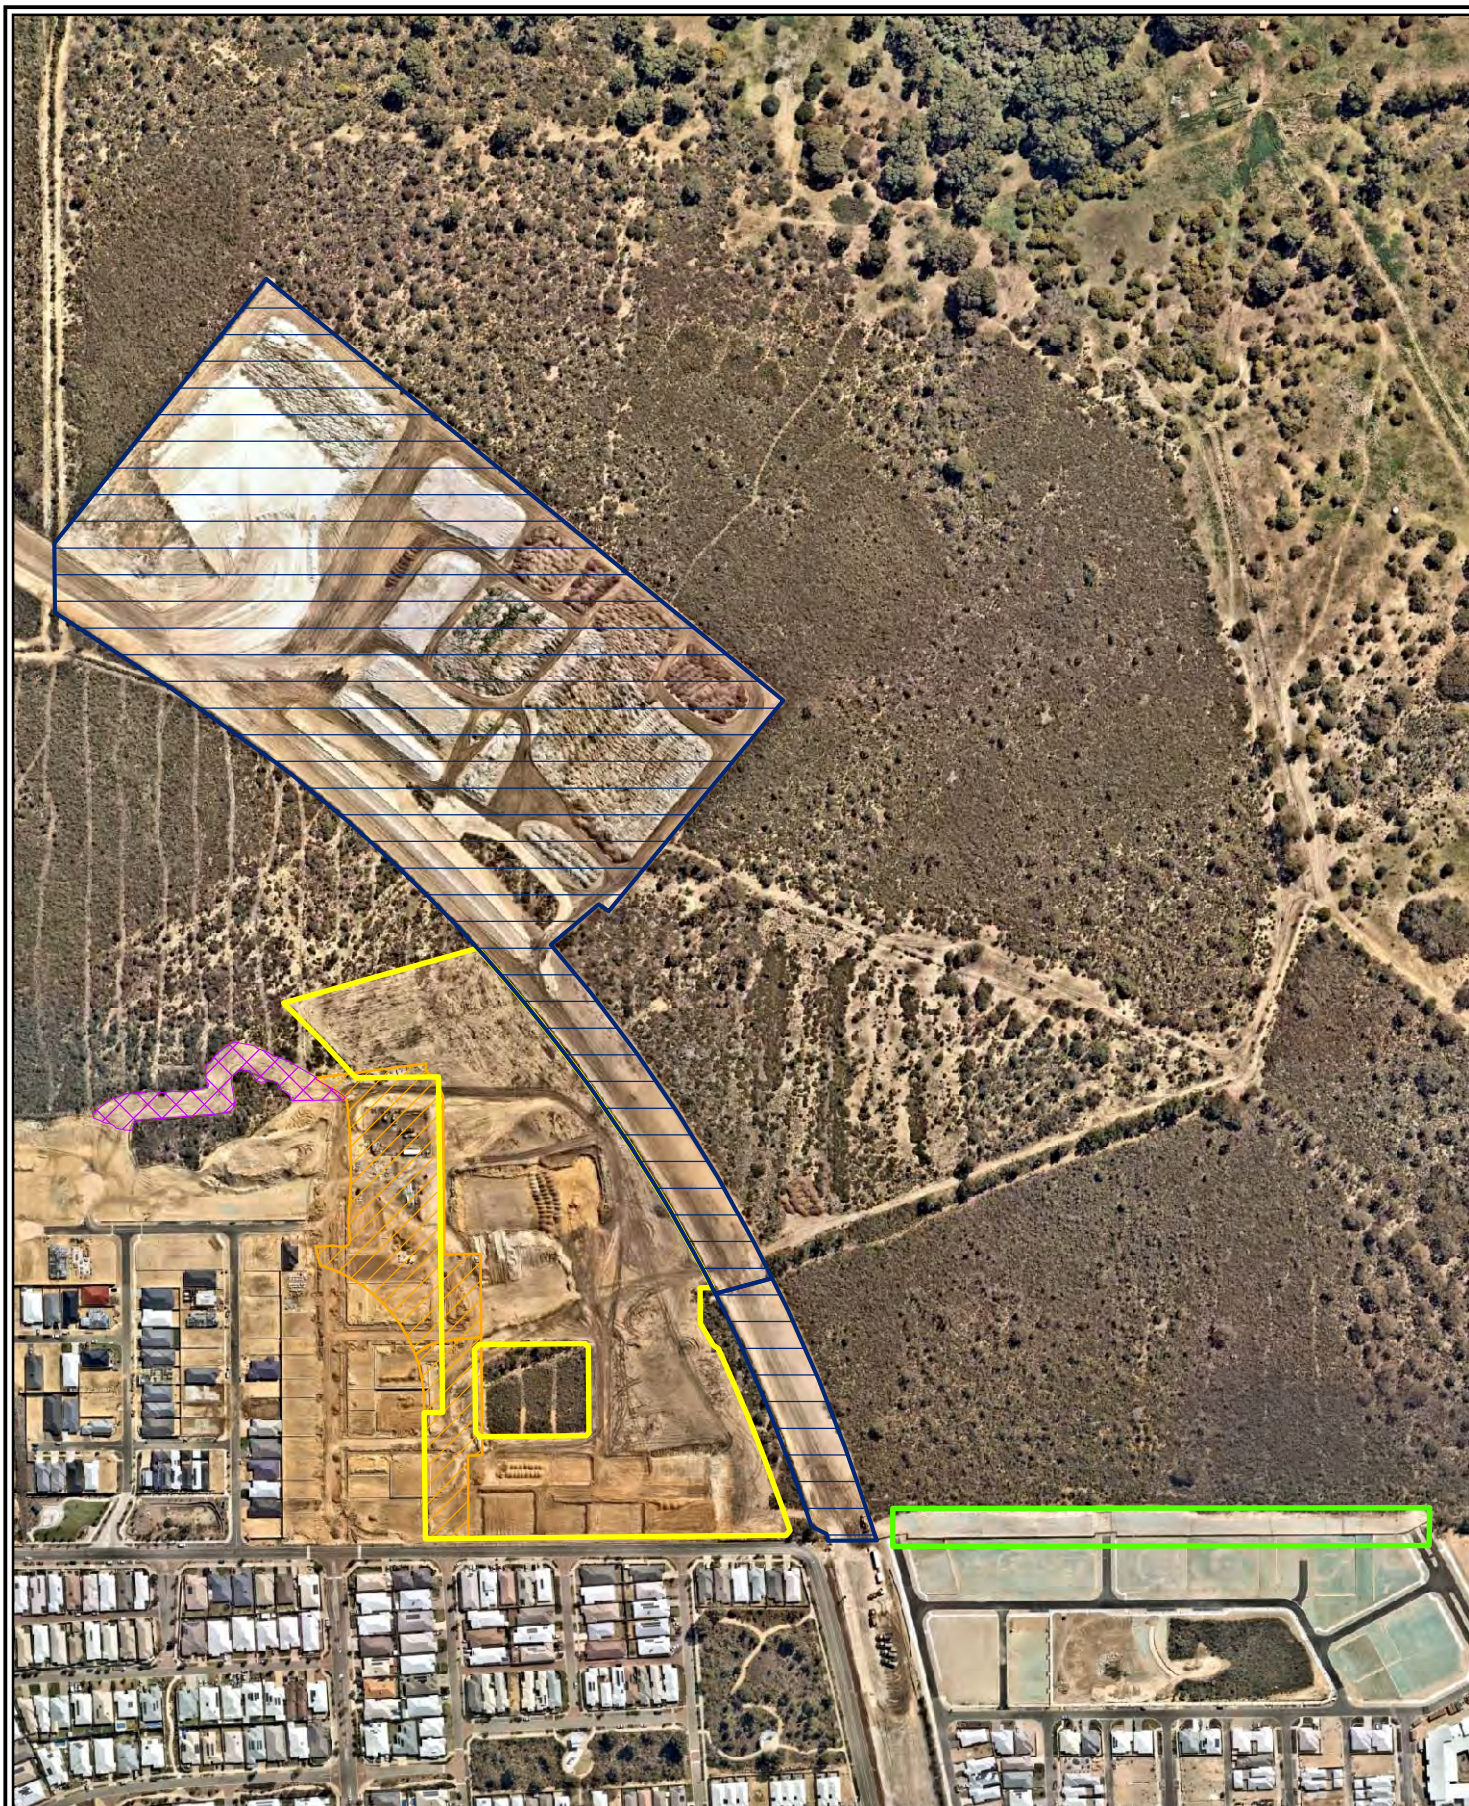
Activities undertaken during the audit period (8 October 2019 – 7 October 2020) involved the following (Figure 2.1):

- clearing of approximately 8.73 ha by Prime Eglinton as part of Stages 2 and 4a.
- civil and bulk earthworks associated with the construction of Stages 2, 3 and 4a.
- clearing of 13.77 ha within the rail reserve corridor in April and May 2020 by the Western Australian Public Transport Authority (PTA) for construction of the Butler to Eglinton railway.
- clearing of 0.675 ha of vegetation by Peet Shorehaven Pty Ltd for the purposes of establishing a bushfire Asset Protection Zone and construction of a limestone retaining wall for finished level differences between the Development and the adjacent Peet Shorehaven development to the south.

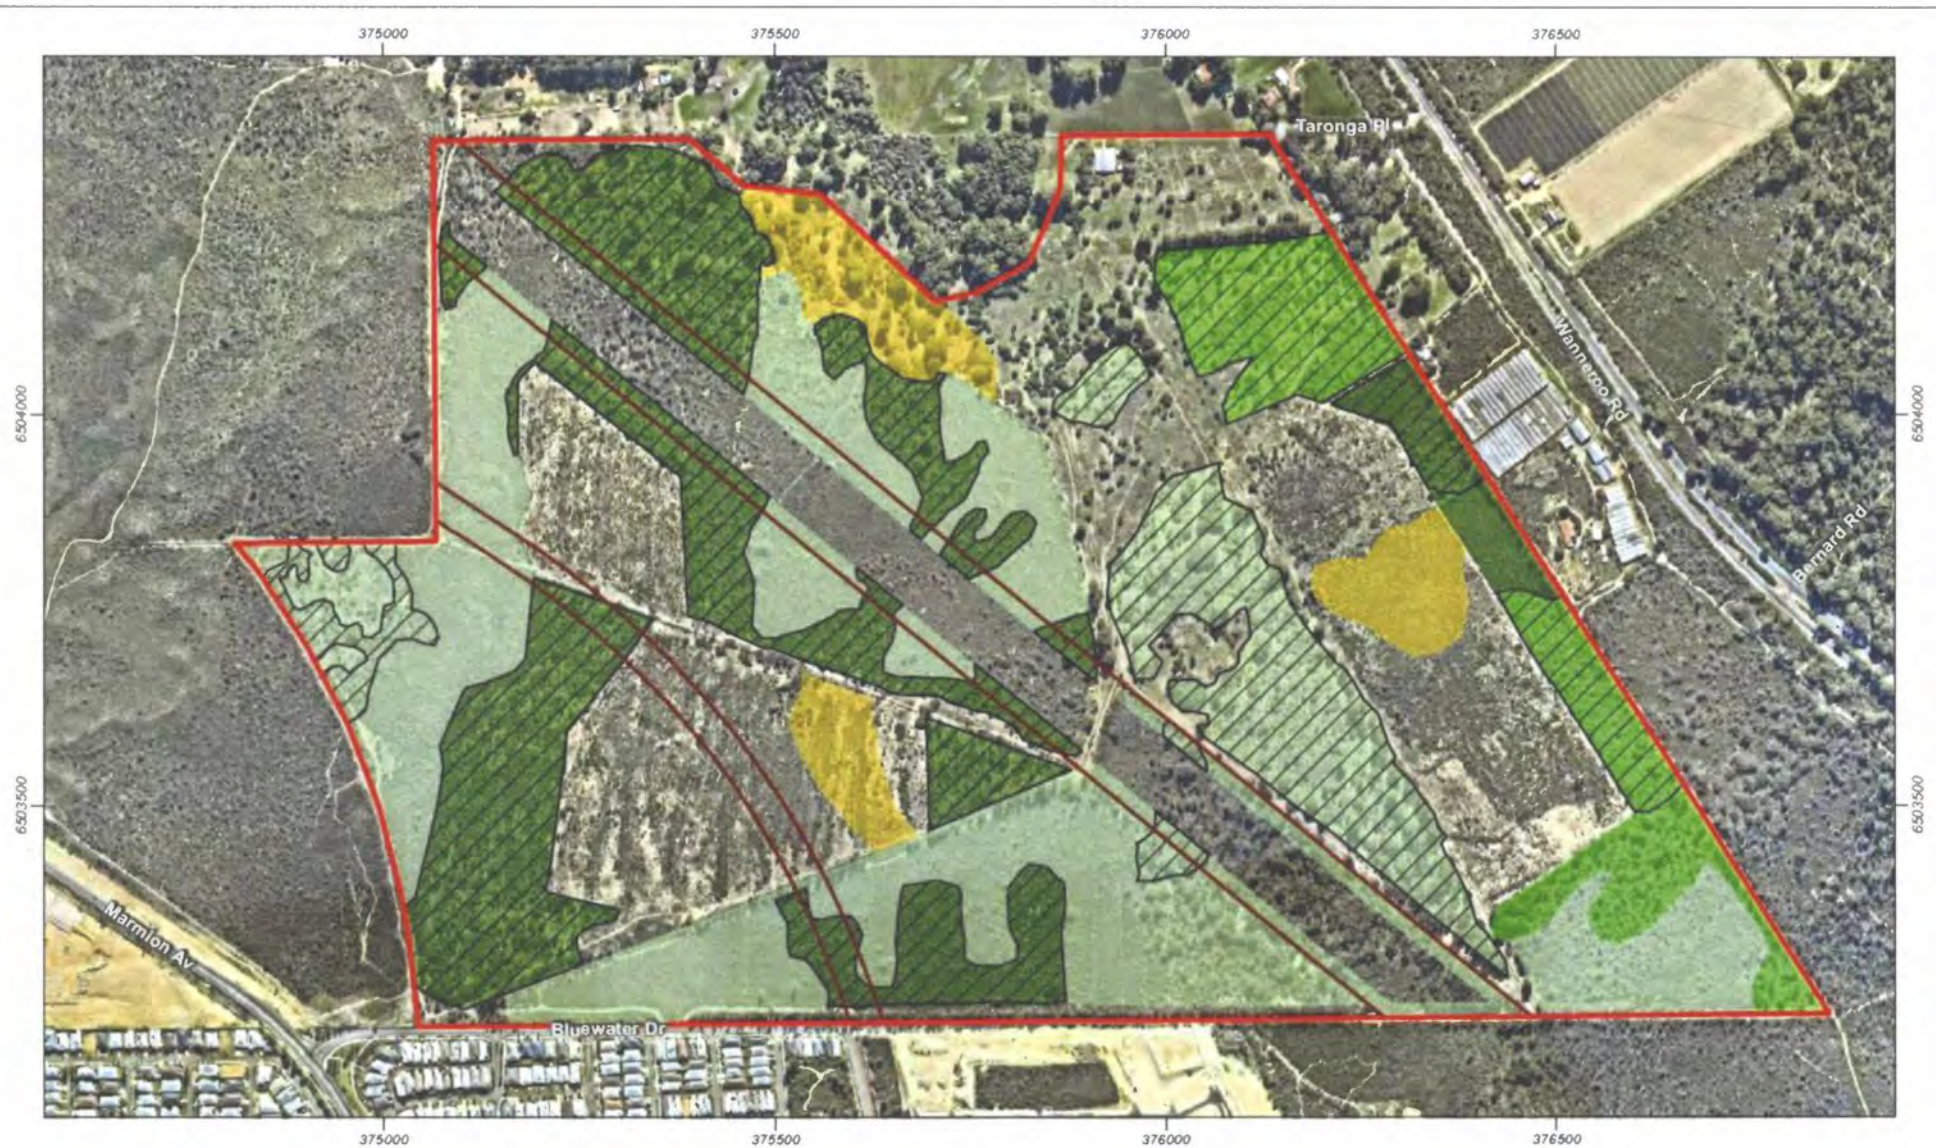
Attachment 1: Project Area

- 3: Low to moderate foraging value
- 4: Moderate foraging value

- 5: Moderate to high foraging value
- 6: High foraging value

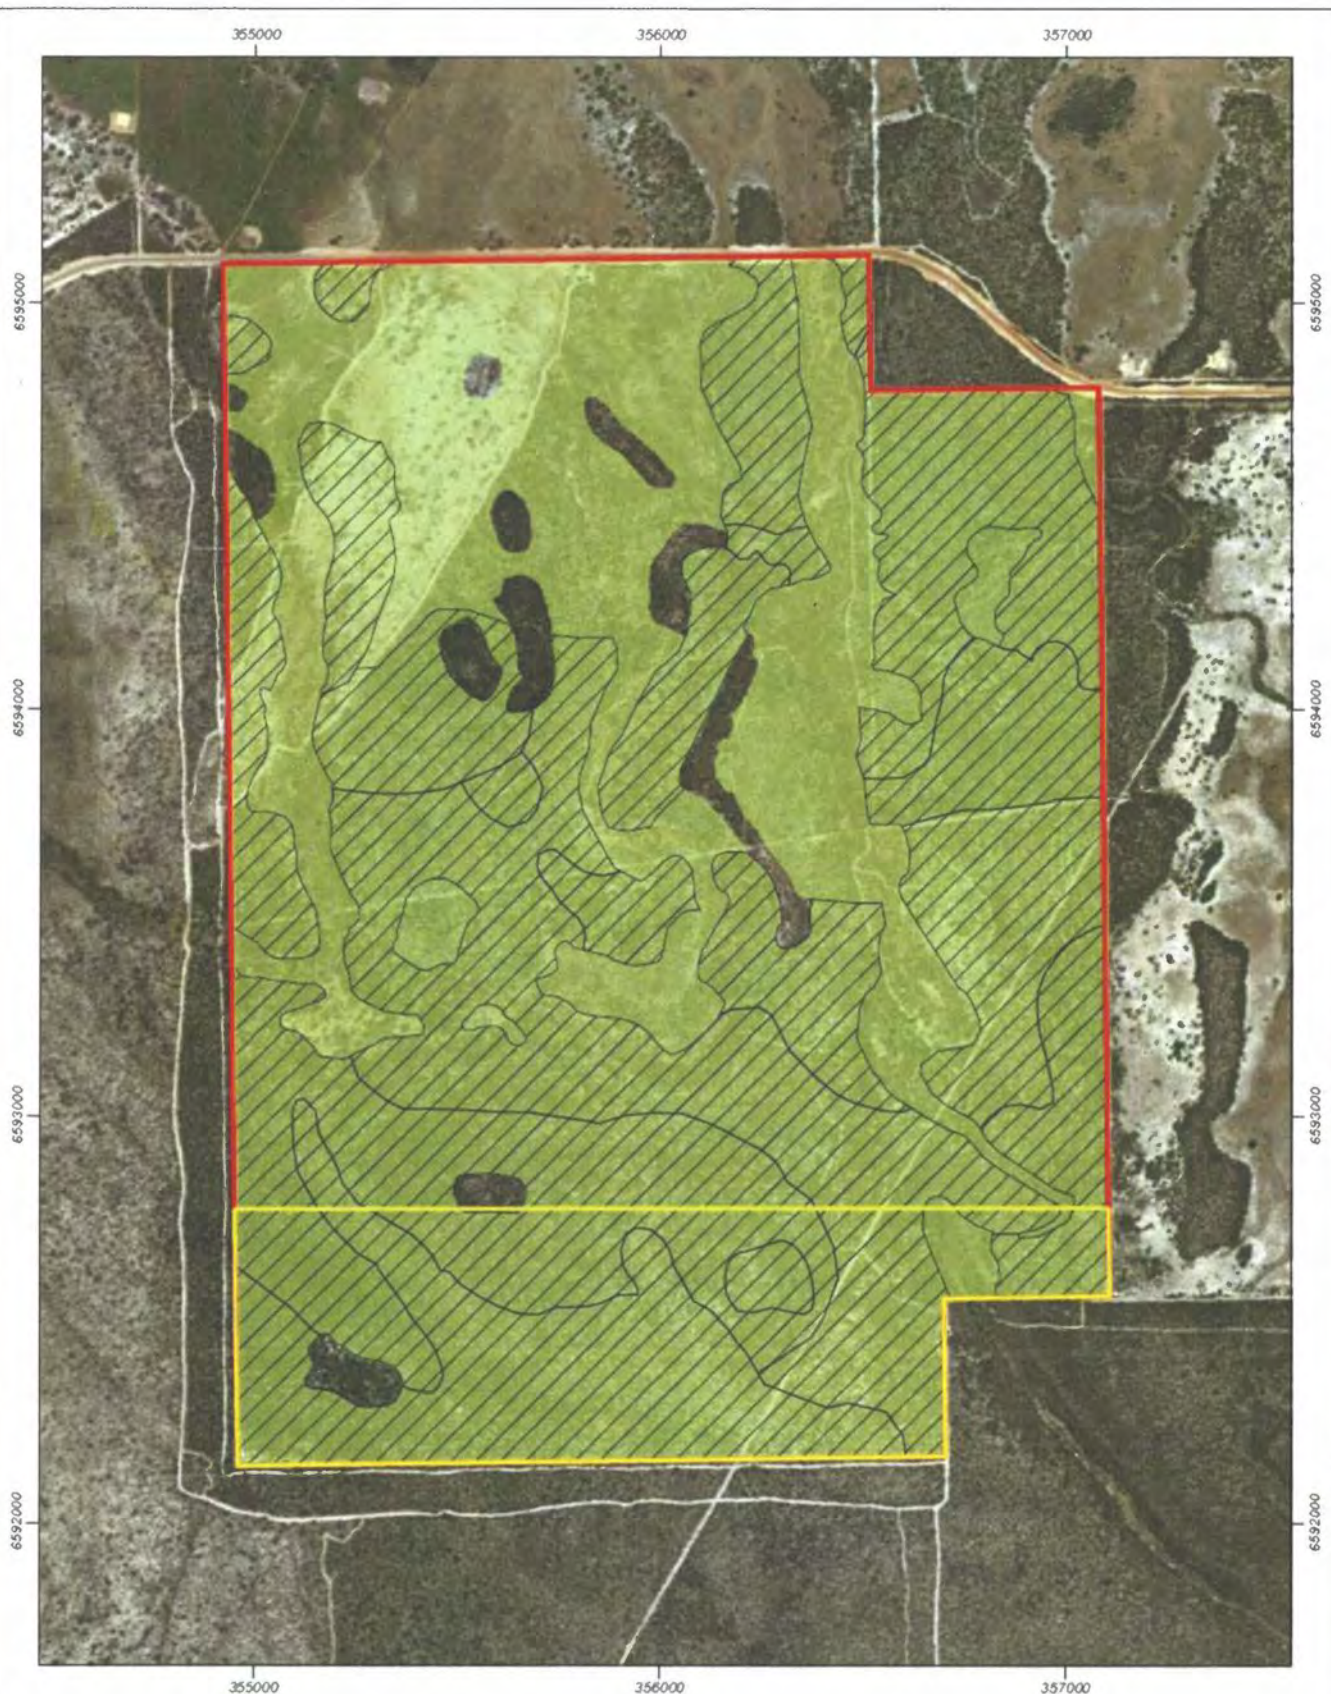
Attachment 3: Lot 3333 Mimegarra Road, Cataby

- Survey area
- Offset area (117 ha)
- Banksia woodland
- Black cockatoo habitat

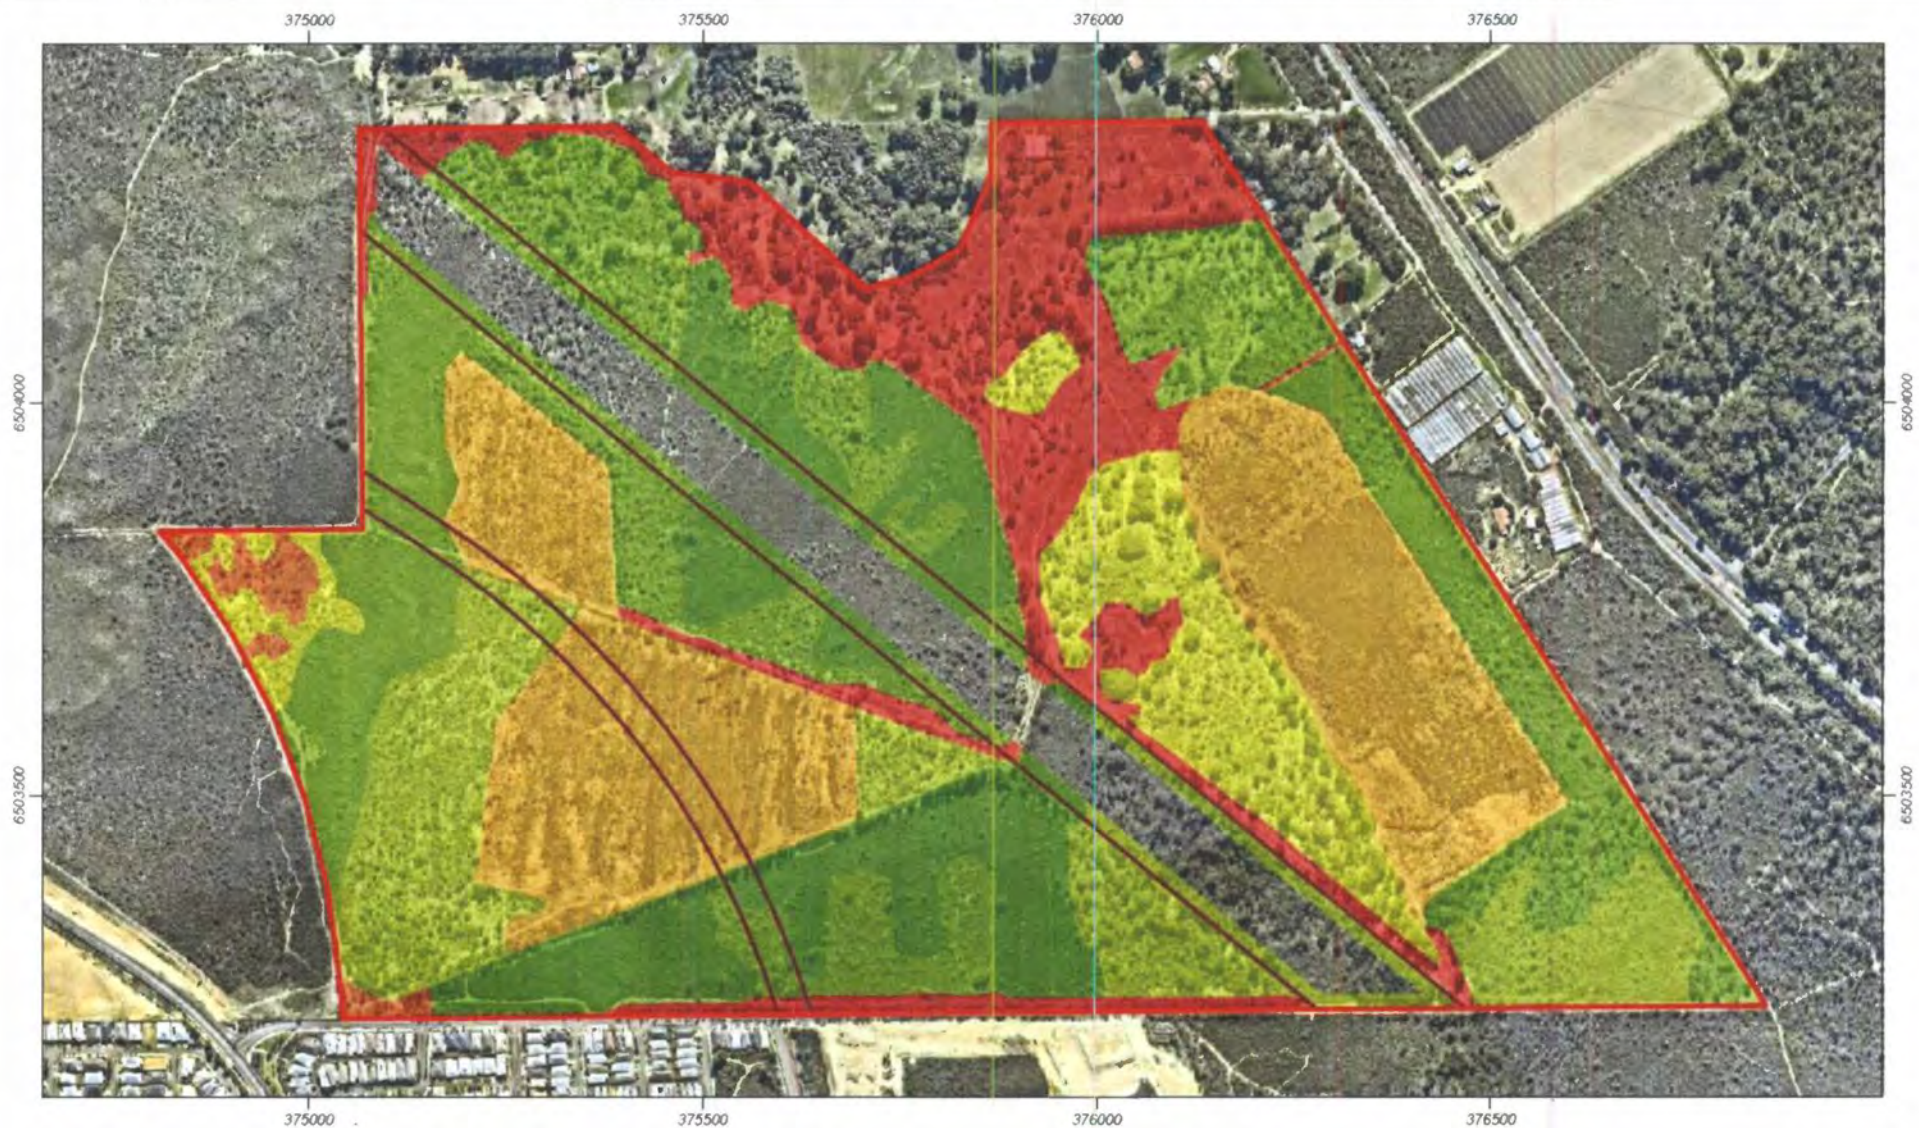
Attachment 4: Vegetation Condition of the Project Area

- Excellent (19.71 ha)
- Very Good - Excellent (39.90 ha)

- Very Good (19.64 ha)
- Good - Very Good (12.16 ha)
- Good - Degraded (33.14 ha)
- Degraded (1.68 ha)
- Completely Degraded (22.83 ha)

- s. **Public Open Space** are the areas of **Carnaby's Black Cockatoo habitat** and **Banksia Woodlands TEC**, totalling at least 8 hectares, which will be ceded to the City of Wanneroo for ongoing management. The vegetative condition of these areas must be at least Very-Good to Excellent as shown in Attachment 4.
